MEMO FOR RECORD

FROM: Andrew Tuthill, ERCC-CRREL-NH

SUBJECT: Freezeup Ice Jam Flooding in Malone, NY.

DATE: January 21, 2004

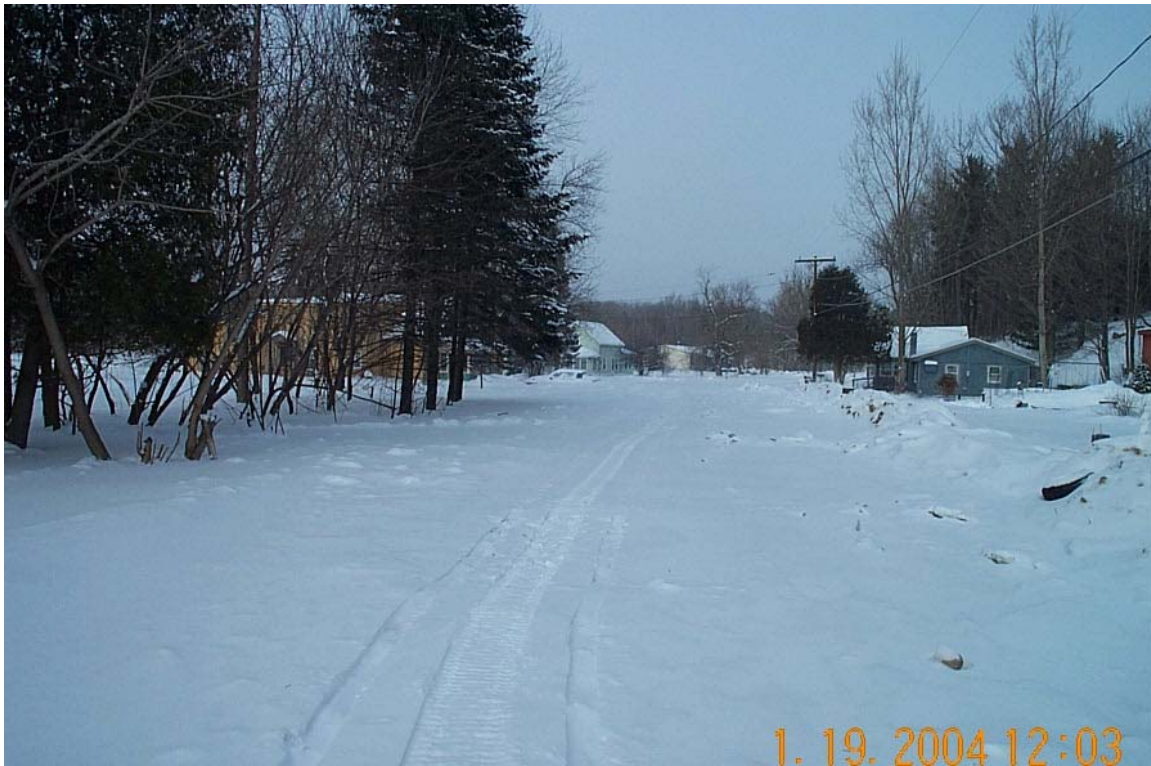
A freezeup ice jam had formed upstream of Lamica Lake, the 14-acre pool formed by the Macomb Hydroelectric Project (Fig. 1). Frazil ice, deposited in the dam impoundment and the river channel upstream, had forced flow into the right overbank, flooding seven houses on the west side of Lower Park Road (Figs. 2, 3 and 4). Six of these houses had been evacuated and three were completely surrounded by water. Town crews had constructed berms of earth snow to protect houses on the east side of the road. The ice jam had formed as the result of the extreme cold of January 8-16. Fig. 5 shows air temperatures during this period to be well below the seasonal averages. By Jan. 19, stages had receded slightly due to the more moderate temperatures of Jan. 17-18.

Fig. 3. Lower Park Rd. Flooded houses are on the left.

By Jan. 21, Malcolm Jones reported that water levels had dropped sufficiently to re-open the road and begin pumping out the basements of the flooded houses. Hopefully the extreme cold forecast for the next few days will not cause renewed flooding.

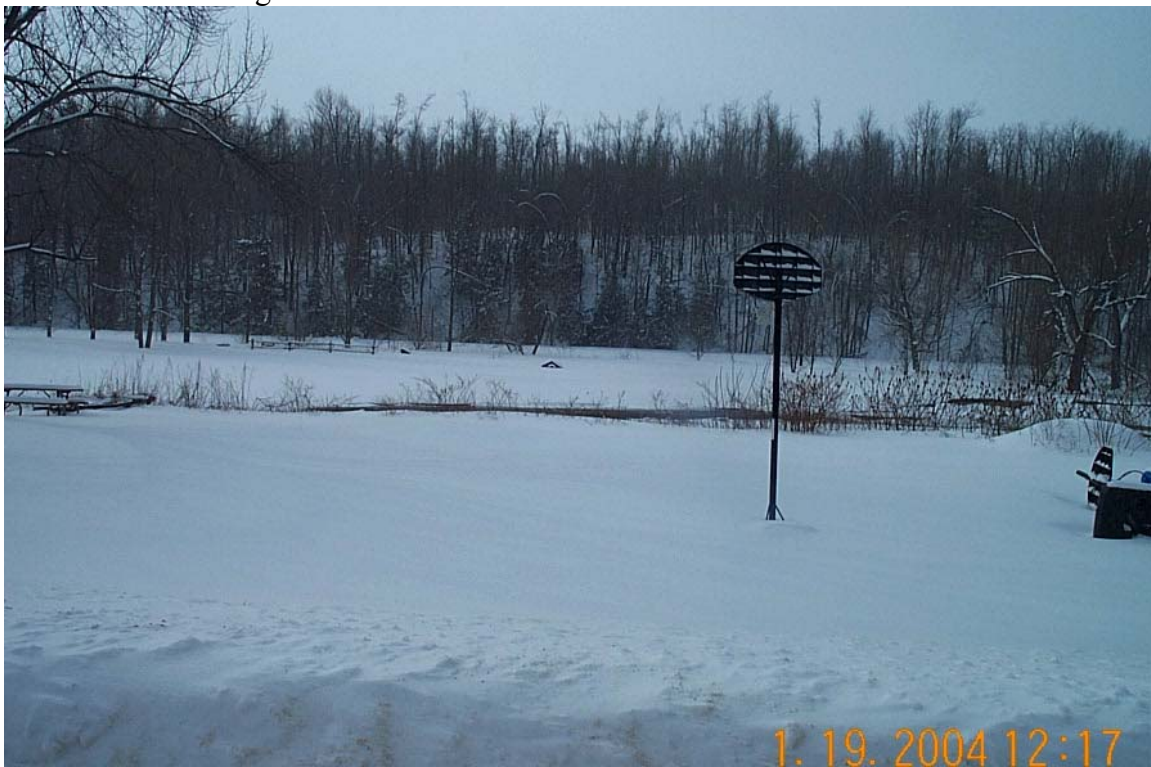
Fig. 4. Looking west from Lower Park Rd. In the distance, the ice jam in the main channel has forced flow out of bank in the foreground. Note the well house roof protruding above the water and ice near the center of the photo.

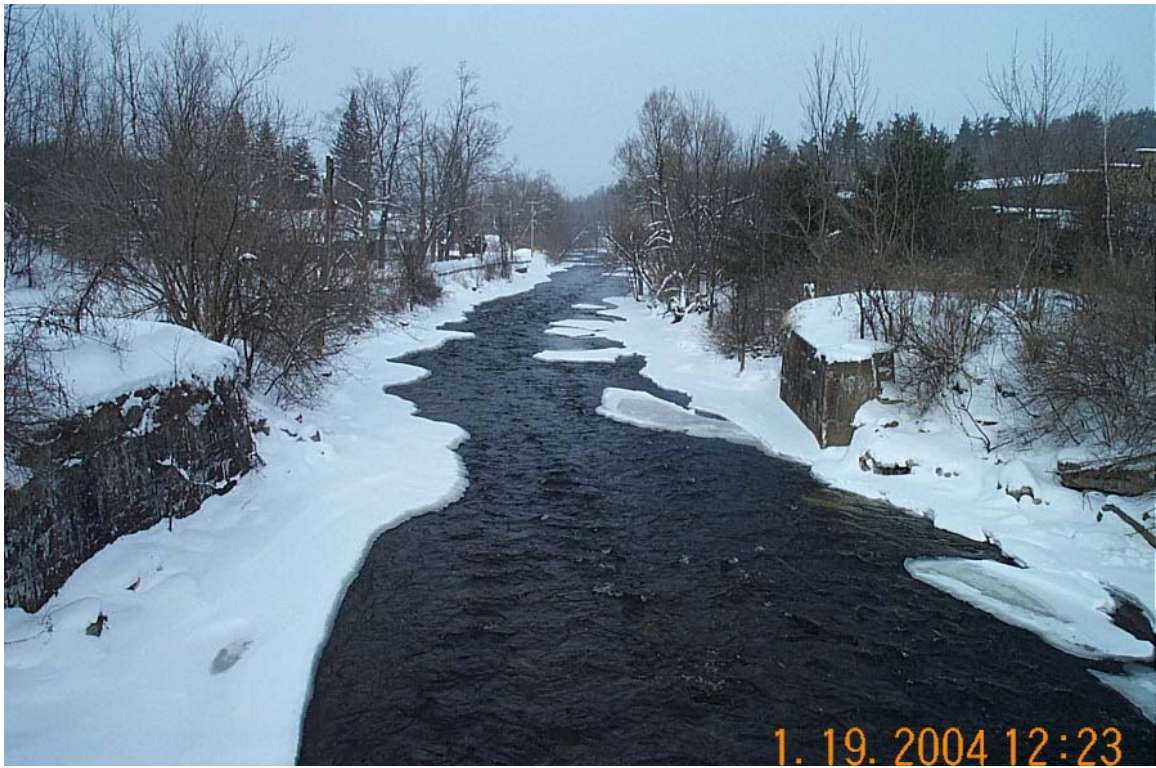
On midday on Jan. 19th air temperature was about 10°F and the 2-mile-long reach between Malone village and the flooded area was fast flowing open water with border ice but, no evidence moving frazil or anchor ice (Fig. 6). During the previous sub-zero period however, Jones and Dumas had observed heavy frazil ice moving through this reach. Above the two dams in Malone village, the Salmon River was again ice covered suggesting that most of the frazil ice in the Lower Park Rd. jam was generated in the open water section downstream of the city.

Fig. 6. Open water reach between Malone Village and Lower Park Rd.

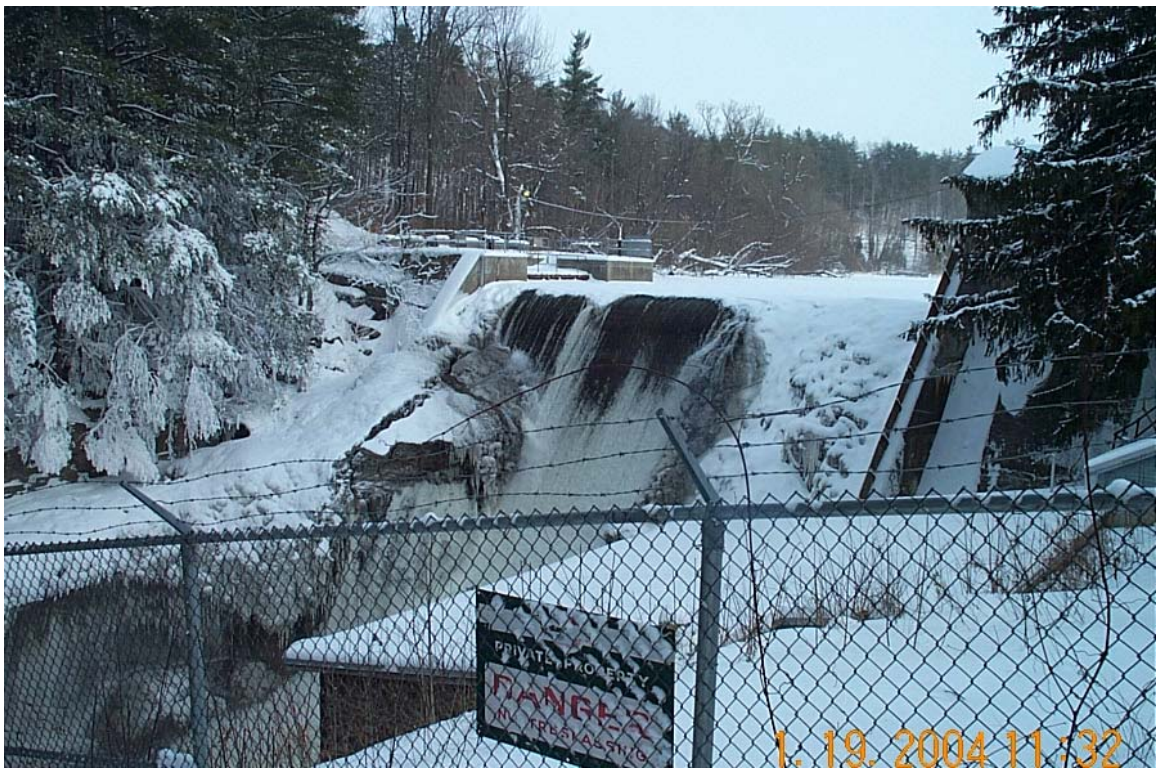
The Macomb Project, operated by Reliant Energy, consists of a 27-ft-high dam built in 1899 and a powerhouse with single 1000 MW turbine (Fig. 7). Allowable drawdown is 1.0 ft, and turbine capacity is 310 cfs. Any flow in excess of 310 cfs passes the dam spillway, which has no flashboards. On Jan. 19th, Salmon River discharge 7 miles upstream at the Chasm Falls Project was 147 cfs, well below the Macomb average January discharge of 271 cfs. During our visit, a crew was in the process of deicing the trashracks at the Macomb Project, and, as a result of this blockage, some flow was passing the spillway.

Fig. 7. Macomb Project.
